MINNESOTA HISTORICAL SOCIETY

## THE CONSERVATION OF AN 1879 HASKELL AND BARKER WOODEN BOX CAR

By Paul S. Storch, Senior Objects Conservator  
Daniels Objects Conservation Laboratory  
Minnesota History Center  
Minnesota Historical Society

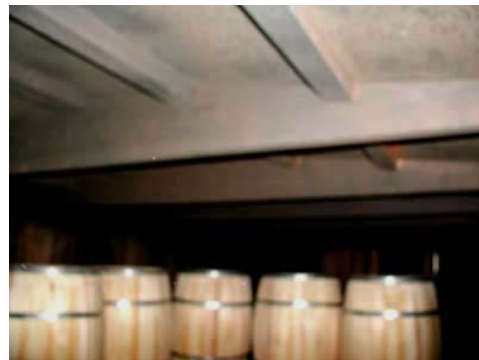
Figure 5: Interior view of the ceiling.

Once the interior was cleaned, the previously restored unpainted ceiling was toned with Liquitex acrylic dispersion paint applied with an airless sprayer. In order to show how the box car was used at the mill, empty reproduction flour barrels were acquired and are displayed inside.

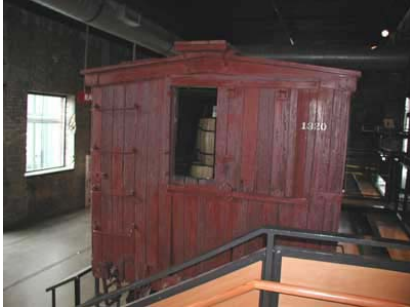
The window end of the box car sustained the worst damage to the paint on the siding boards. The paint layer was brittle and had lifted off the wood siding surfaces. The treatment consisted of consolidation of the existing paint with Rhoplex 234 acrylic emulsion adhesive solution 1:1 in deionized water. The solution was brushed under the lifting paint and allowed to set. The consolidated paint was heat-sealed to the wood with a tacking iron over silicone-release polyester film. This method was used over the extent of the siding boards where there was lifting paint.

Figure 6: View of window end of box car after paint consolidation and in-painting.

When the paint was stabilized, the loss areas were in-painted with Liquitex acrylic dispersion paints to blend in with the existing paint color.

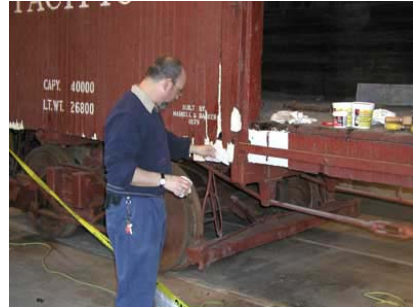
Figure 7: Wood fills being applied by the author.

Structurally unstable areas of the siding boards were first consolidated with Abatron two-part Liquid Wood epoxy wood consolidant. When the epoxy set up, the broken areas were mended with poly-vinyl

acetate emulsion wood glue and clamps. Once the boards were properly positioned and mended, loss areas were in-filled with Abatron Wood Epox two-part epoxy putty and surfaced with Permafix acrylic emulsion putty. After smoothing with sand paper and a compressed air rotary grinding tool, the fills were in-painted with Liquitex acrylic dispersion paints.

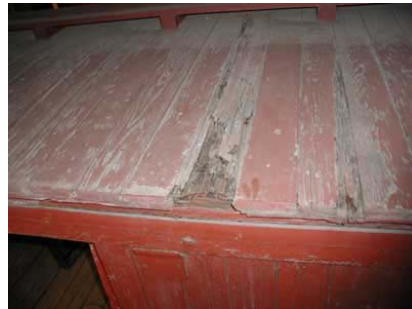
During display at the Transportation Museum, water and weather damage to the roof necessitated replacement of the entire roof structure sometime during the 1980's. There were areas of recent water damage to a section of the roof boards and underlayment and to lower areas of the exterior siding boards.

Figure 9: View of deteriorated roof boards before treatment.

The proper left front end of the roof had an approximately six foot long area of boards that had sustained severe water damage during outdoor display and were no longer structurally stable. The rotted wood was powdering and breaking off.

The deteriorated boards were removed and discarded of. The underlying plywood roof support was cleaned. Remaining parts of the outer boards were consolidated with the Abatron Liquid wood epoxy.

New pine flooring boards were purchased and cut to fit the loss areas. The new boards were attached to the roof with screws. The new boards were toned with Liquitex acrylic dispersion paints to blend in with the existing roof color.

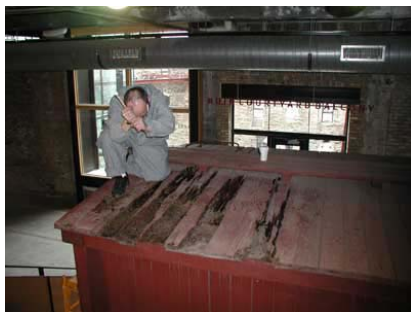
Figure 10: Detail of roof board stabilization in progress. The darker areas show where the liquid epoxy was used.

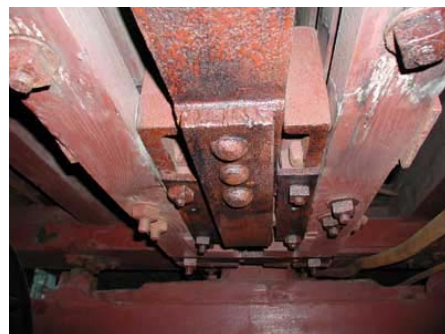
Figure 15: Tannic acid/resin treatment results on metal components with paint remnants.

The metal surfaces were cleaned with compressed air needle scaling tools and rotary steel brushes. The heavy corrosion products were removed down to a more even oxidized surface. The metal surfaces were then brush coated with Rust-X corrosion stabilizer. The formulation consists of tannic acid and a water-based ethylene vinyl acetate (EVAc) resin and can be used on painted surfaces as well as on raw metal. The tannic acid reacts with the corrosion products and forms a stable surface. The EVAc resin forms a durable coating over the surface, obviating the need for further coating.

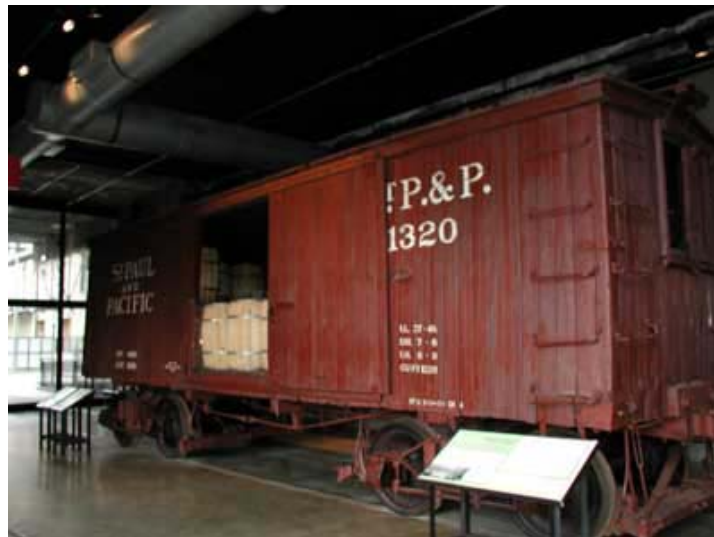
The treatment has returned the box car to an as-used, well-maintained condition. The treatment as described here took approximately 90 hours to complete. Ted Bores, who held the position of Objects Conservation Lab Technician from 2000-2003, assisted with the treatment.

Figure 18: Overview of the completed box car.
